2D Resistivity Tomography Survey for Leachate Plume from Isundunrin Poultry Disposal Pits

***Fakunle, M. A., Alabi, O. O., Olatona, G. I., Oladejo, O. F. and Adeleke, J. T.**

Department of Physics, Osun State University, Osogbo, Nigeria

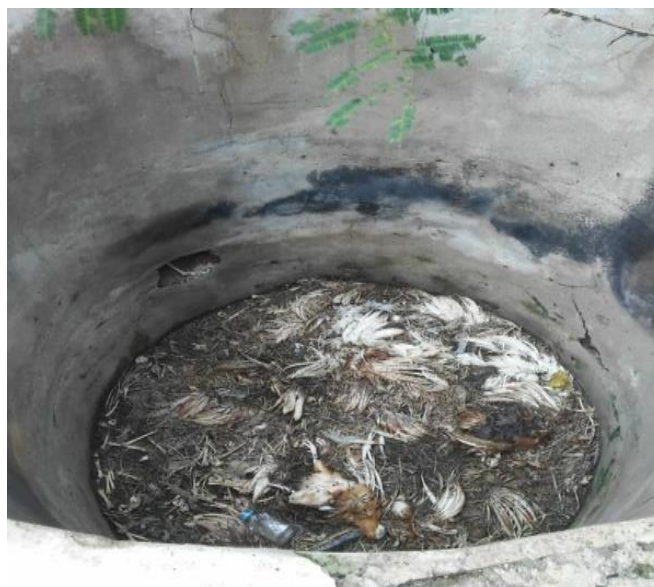
Figure 1: Mortality Pit

The study site, an active poultry farm in which the mortality pits (figure 1) are located, is in Isundunrin and is just 2.0 km from the middle of the town. It is easily accessible from Ejigbo by major tarred roads, minor un- tarred roads and footpaths in Ejigbo Local Government Area of Osun State, South Western Nigeria. The farm lies within longitude E04°16' 34" – E04° 15' 46" and latitude N07° 51' 32" – N07° 51' 52". The study site lies within the tropical region of Africa and the climate condition is characterised by alternating wet and dry seasons. The wet season is characterised by heavy rainfall that starts in March and ends in October while the dry season is from November to February. The mean annual rainfalls are 150.0 cm, and mean annual relative humidity is above 80% while the mean annual temperature is about 28°C. The vegetation of the study area resembles that of the South Western Nigeria, which is evergreen. Around the study site are residential buildings which makes the sparse while away from it are thicker vegetation. The environs of the location site are well drained with much drainage exhibiting dendrites patterns. Many of the rivers and streams are structurally controlled which favoured the growth of many wet lands around the underlying site. Figure 2 is the location map of the study site.

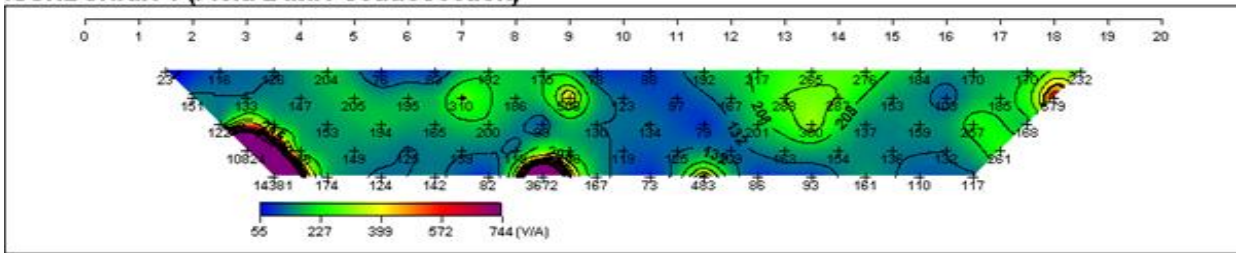
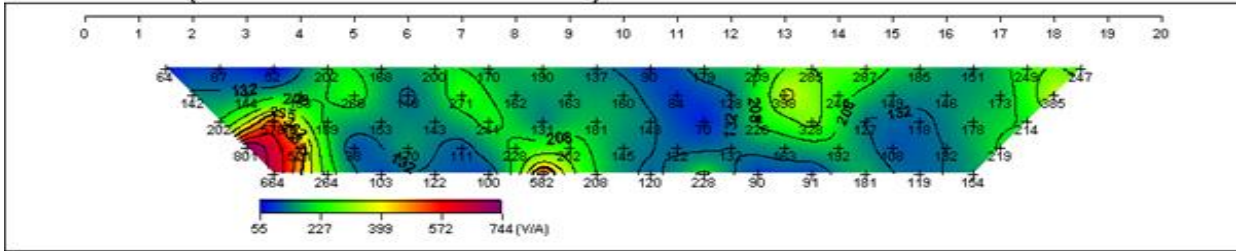
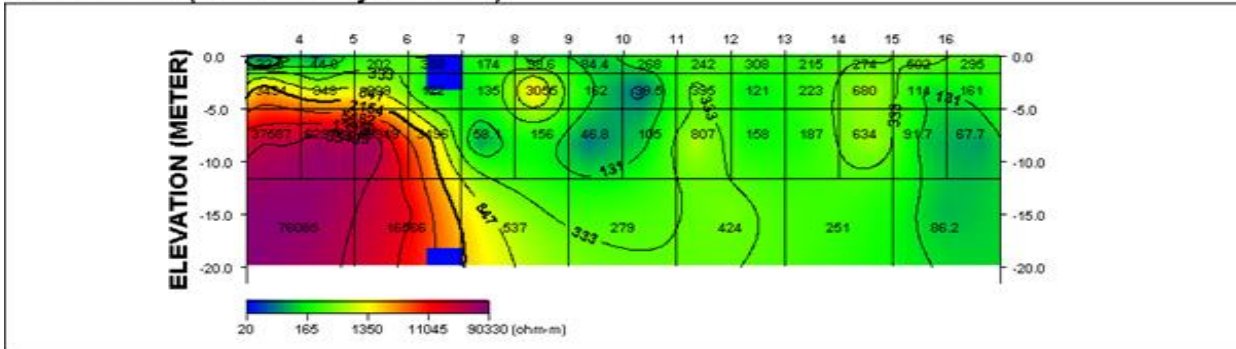
Figure 4: 2D inversion model along traverse 1, 3 m from Mortality Pit 1

The 2D resistivity structure along transverse one (Figure 4) shows in the NE direction and 5.0 m away from the mortality pit 1, showed a varying resistivity values across this transverse (Figure 4) with some portions being highly resistive, while some parts are of low resistivity (conductive). In this part of the study site, the major subsurface layers delineated are the topsoil (174 – 308 Ω m), weathered basement (424.0 – 880.0 Ω m) and basement rock (90330.0 Ω m) which are marked by different colours (Figure 4). The low resistivity values 46.8 to 131.0 Ω m recorded at points 9, 10, 18 and 20 are indications that the leachate plume had travelled horizontally distances range of 45.0 to 55.0m and 80.0 to 100.0 m at depths greater than 10.0 m and more than 20.0 m as shown in figure 4 (the blue and light blue portions). This could be the host of the contaminant resulting from the decomposition of the dead birds since these contaminants migrated from the mortality pit. The resistivity values of the contaminant increased as the contaminant migrated down due to the decrease in density and filtration that had happened. The extent of the contaminant is very prominent at the depth of 5.0 m. The effect of this contaminant was not noticeable at about 15.0 m at points 9, 10 and 11 along the profile length due to the presence of clay soil. The yellow, red and purple portions of the structure are of higher resistivity values ranging from 1350.0 Ω m to 90330.0 Ω m typical of lateritic material and basement rocks. The thickness of which is about 20.0 m. The lateritic soil and basement protected the study site from further contamination.

ISUNDUNRIN 1 (Field Data Pseudosection)

ISUNDUNRIN 1 (Theoretical Data Pseudosection)

ISUNDUNRIN 1 (2-D Resistivity Structure)

In this study, 2D electrical resistivity has been successfully used to identify the extent (depth and lateral) of migration of leachate from poultry mortality pits. It was also used to delineate the various subsurface layers present at the study site. The 2D electrical resistivity imaging delineates resistivity zones to be low. The results obtained showed that the surrounding soil and groundwater were contaminated by the migration of leachate from the mortality pits to a depth of more than 20.0 m. High values of TDS and conductivity recorded in the analysis of water samples in the wells in the vicinity of the disposal pits were evidence that leachate had migrated from these disposal pits to contaminate groundwater and soils. These results were in perfect agreement with the results of the 2D analysis of traverse 1
